Report of Structural Geologic Investigation

Red & Bonita Mine

San Juan County County, Colorado

August, 2007

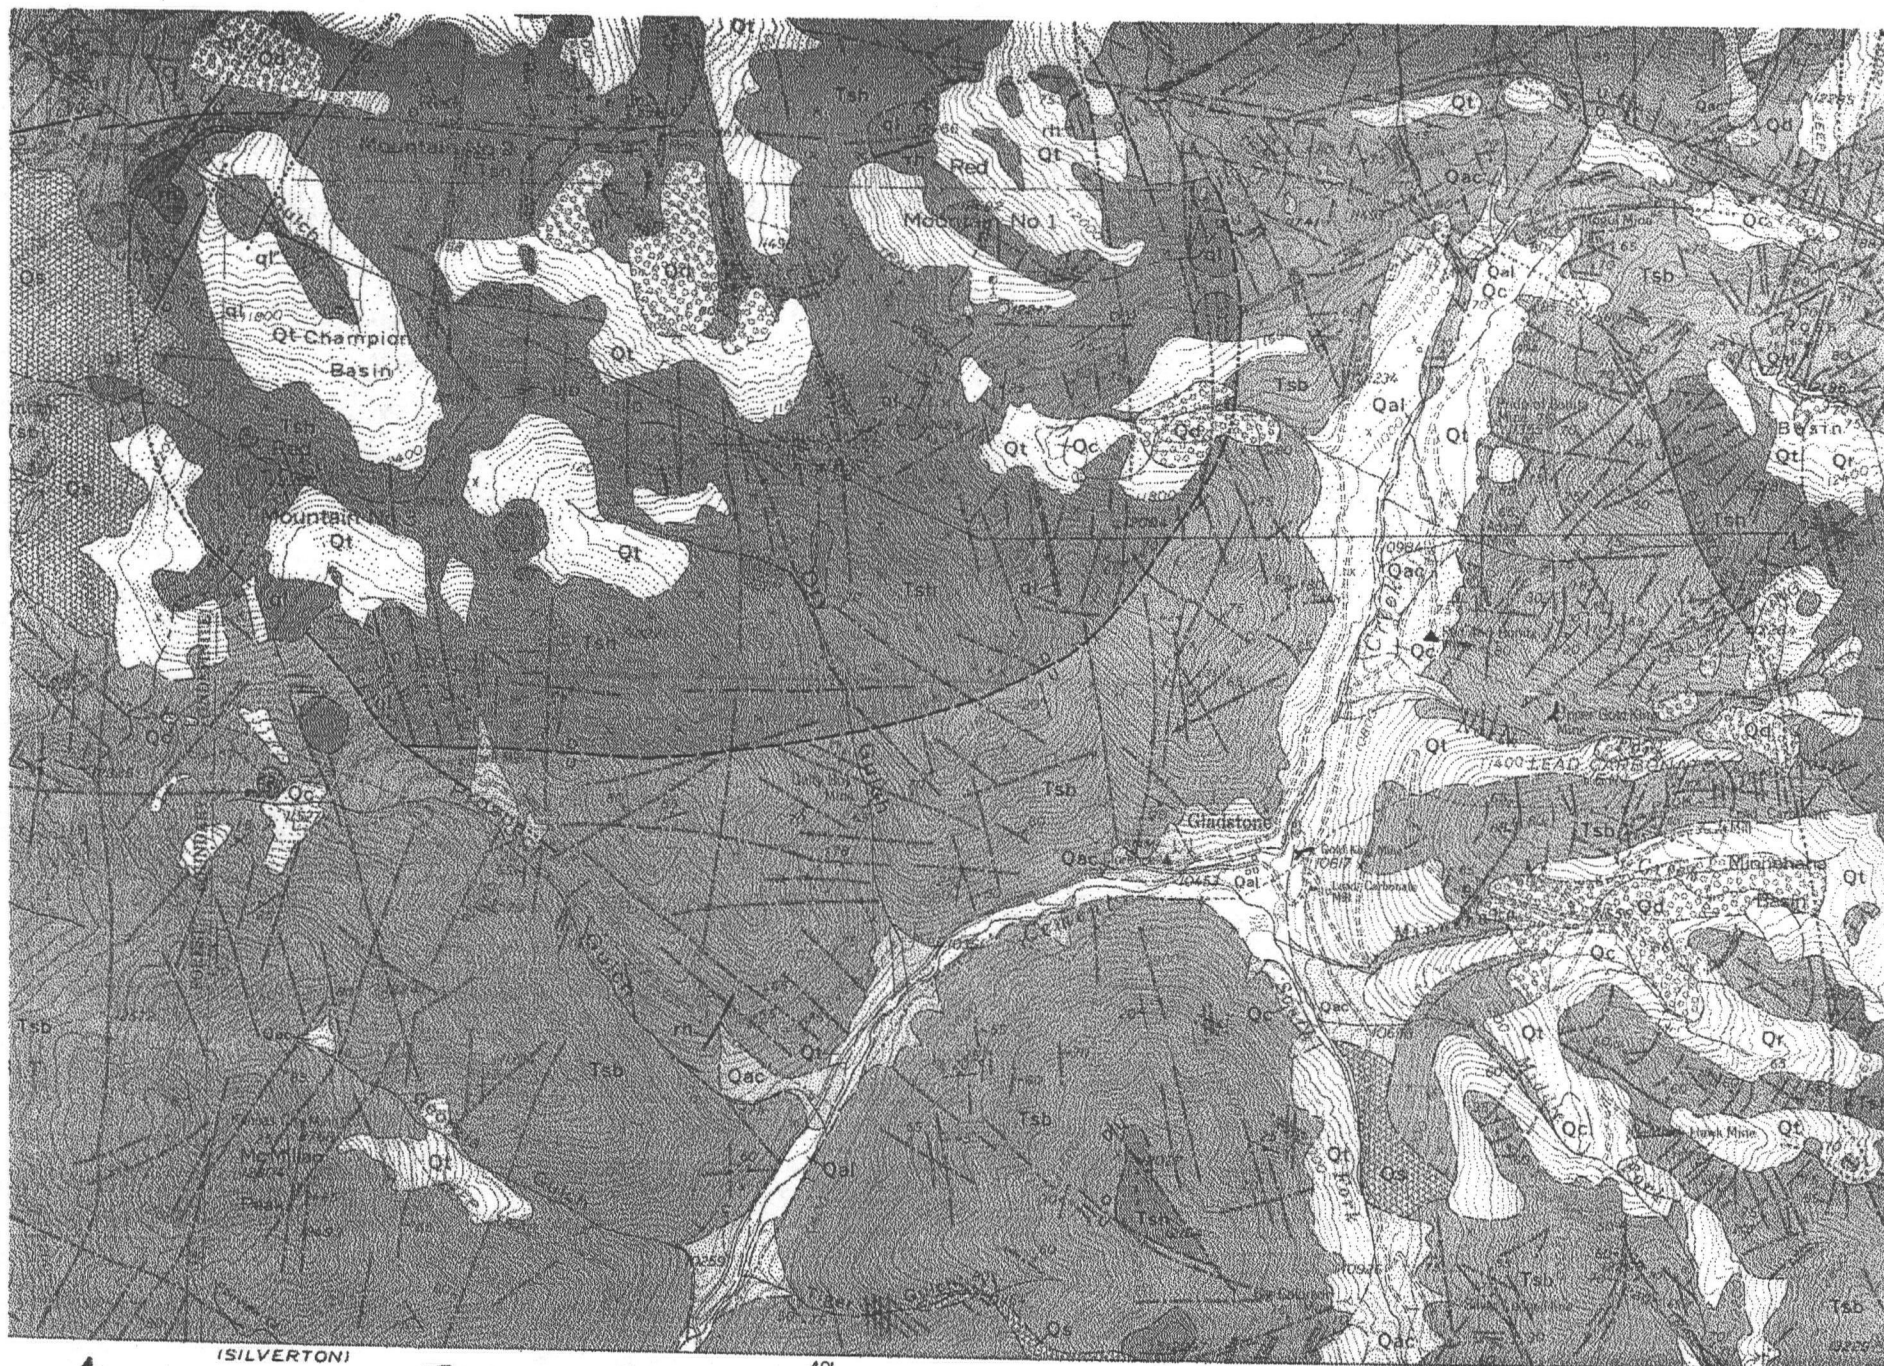
FIGURE 2. SURFACE GEOLOGIC MAP, RED & BONITA MINE AREA.

Structurally, the Red & Bonita workings lie entirely within the Burns Member described above. The Gold King Vein system lies 2,200 feet east of the portal, and the Bonita Fault lies 3,600 feet east of the portal (Figure 2). At least four other un-named but mapped mineralized fissures striking roughly NE-SW occur in the ground between the portal and the Gold King vein structure (Burbank and Luedke, 1964). There are also five localized, mineralized fissures exposed in the gulch below the Gold King waste dump, however, these do not appear to continue farther north into the R&B ground, and there was no evidence they are the locations of surface groundwater discharge.

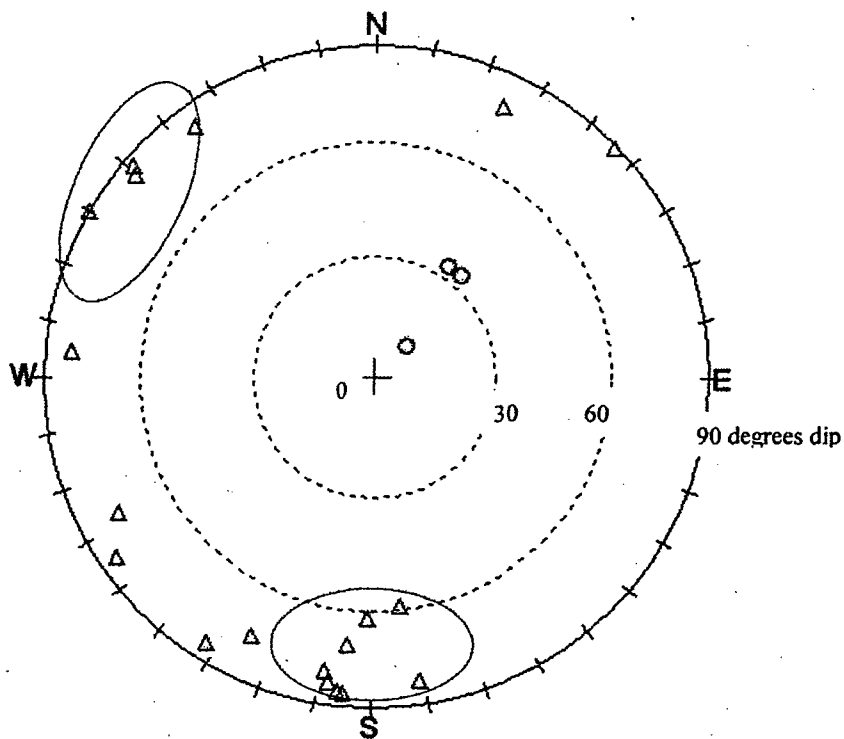
Figure 3. Pole plot of surface planar discontinuities measured around the Red & Bonita Workings. Triangles indicate poles of minor joints; circles indicate poles of flow laminations in andesite rock. The plot shows a cluster of poles to the south and a weaker set in the northwest sector, indicating two trends of anisotropy in the surface bedrock.

The southern pole cluster represents a set of joints trending roughly east-west, with dips of 60 to 89 degrees to the north. The northwest pole cluster represents joints striking roughly northeast-southwest, dipping steeply southeast. These orientations are similar to the dominant northeast-southwest anisotropy noted in the Simon Hydrosearch report prepared for the Sunnyside Mine (Stock, et. al, 1992, 1993). They reported permeability greater in a northeast-southwest direction due to the dominant fracture orientation within this section of the Eureka Graben. The structural discontinuities measured in this study tend to agree with the direction of structural anisotropy as shown on published geologic maps and reports for this area near the Eureka Graben. Flow structure (crude bedding) in the andesite strikes south-east and dips gently southwest.

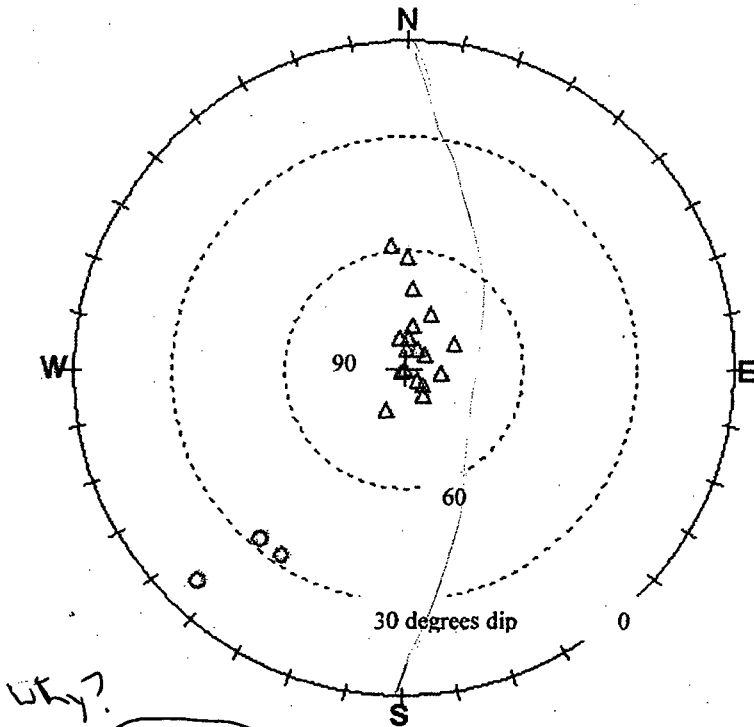
Rock exposed in adjacent mine workings and prospect adits is highly jointed near the portal, becoming tighter with increased distance from surface. This is common in hard rock workings in the San Juan Mountains. Rock near surface is subjected to severe chemical and physical weathering (freeze-thaw, surface infiltration). Release of overburden pressure through erosion, coupled with glacial scouring effects, normally increases fracturing and jointing of the rock mass near surface. As distance from the surface increases, joints generally become fewer and tighter with depth due to overburden pressure. This is important, because the dominant trend of anisotropy is roughly parallel to the trend of the workings in the R&B. Although the structural measurements in this study were collected from surface outcrops, they are believed to be analogous to rock fabric underground in the cross-cut section of the R&B workings. If overburden pressures are not enough to close the minor joints at mine level, a plug in the R&B workings could

Figure 4. Dip vector plot for planar discontinuities measured on surface around the Red & Bonita workings. Triangles indicate dip of minor joints; circles indicate dips of flow laminations in andesite rock. Most joints are steeply dipping, while flow structure has shallow dips.

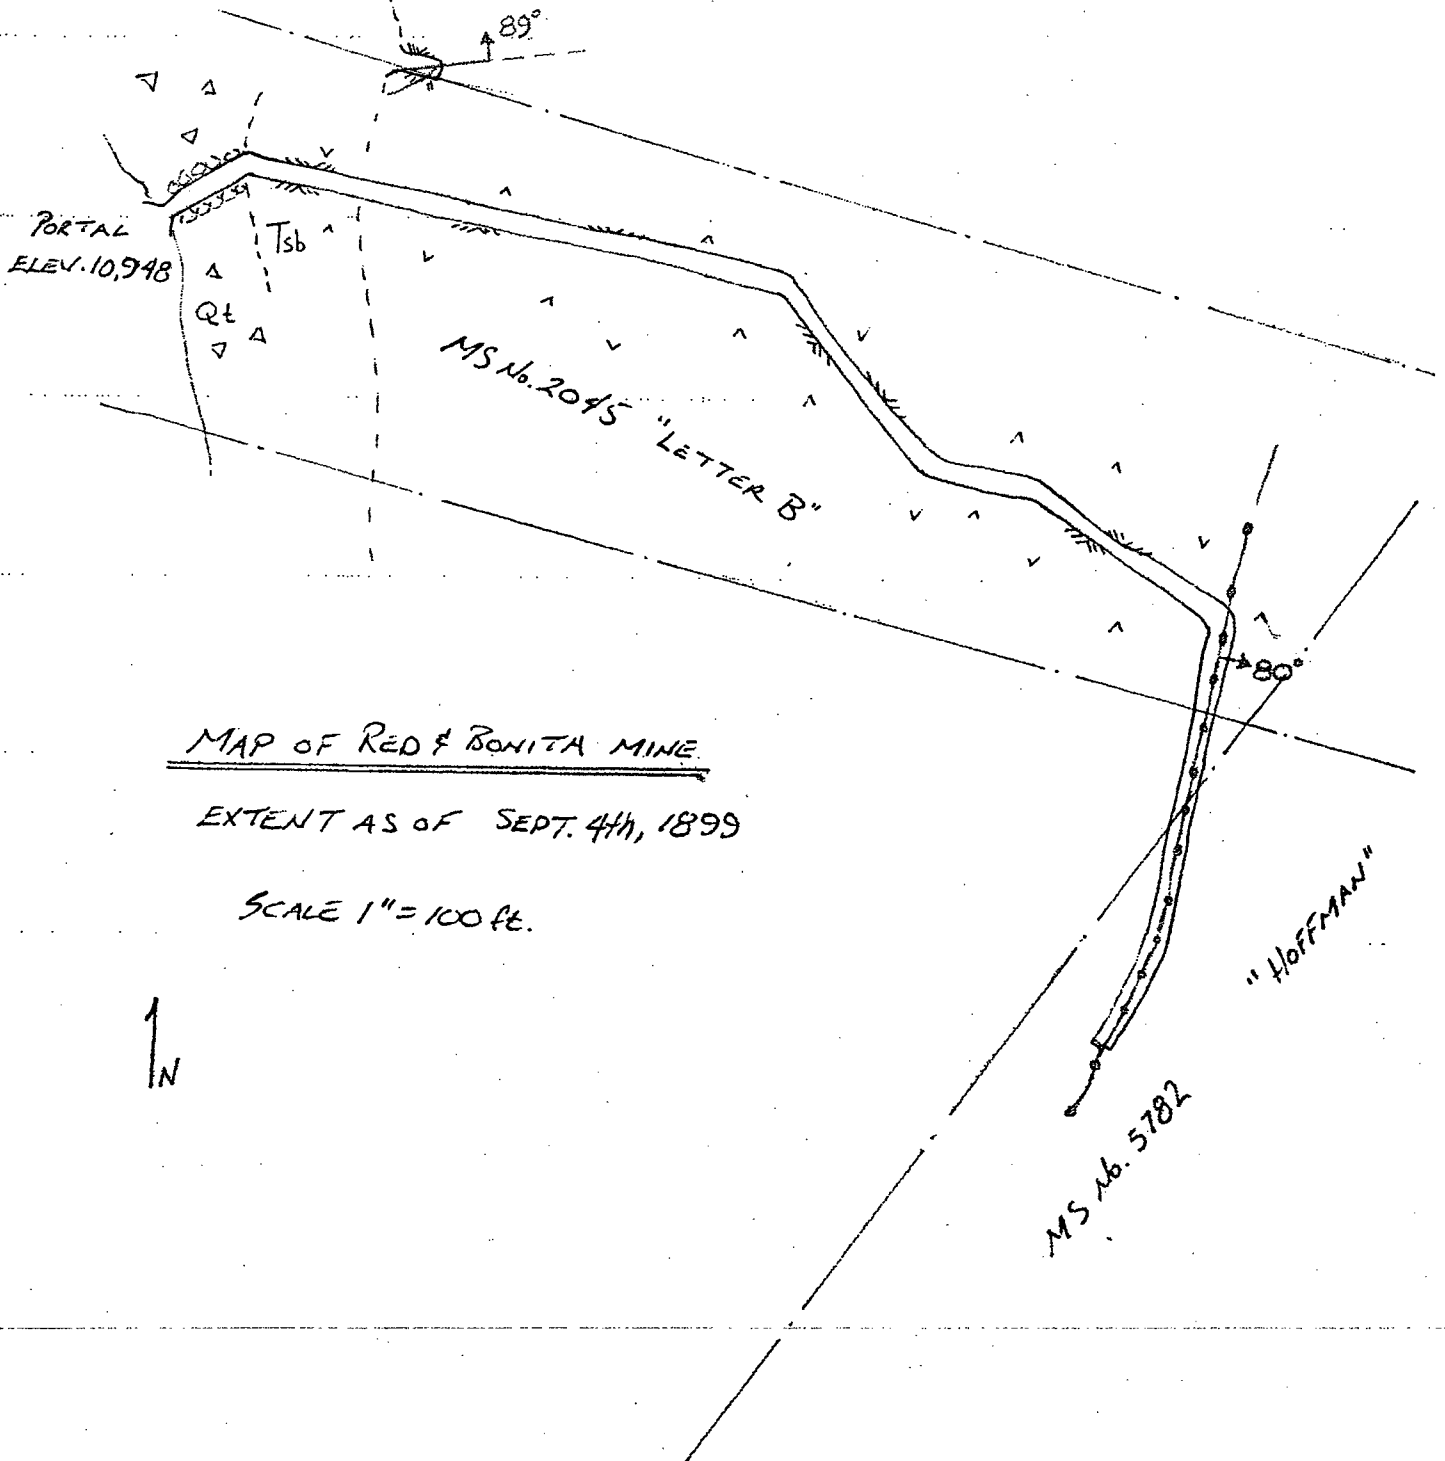
FIGURE 5.

A rudimentary layout of the R&B workings is available from an 1899 mineral survey for the adjacent American Eagle Mill Site (Feam Engineering Services, personal communication, 2007). Based on geologic maps and the 1899 representation of the workings, the R&B adit appears to be a crosscut driven entirely in Burns Formation dacite on a roughly east-south east heading for approximately 665 feet (Figure 5). At 665 feet from the portal, the heading is believed to have intersected a mineralized fissure vein trending NE-SW on the Hoffman Lode. The workings turn abruptly SW and drifted on this structure for approximately 230 feet.

The R&B portal is currently caved at surface where it was timbered through unconsolidated scree and talus deposits. The 1899 mine map shows a distinct change in heading at 30 feet from the portal. This distance might represent the length of original timbered section. Beyond this point, talus deposits underlie which ground is very loose and unstable. To avoid a "mixed face" condition when drilling started into bedrock. Based on the position of the outcropping rock above the portal, and the slope and a visual estimate of the thickness of the talus deposit, fifty feet or a little less is a good approximation of where solid bedrock is expected to be encountered beyond the portal.

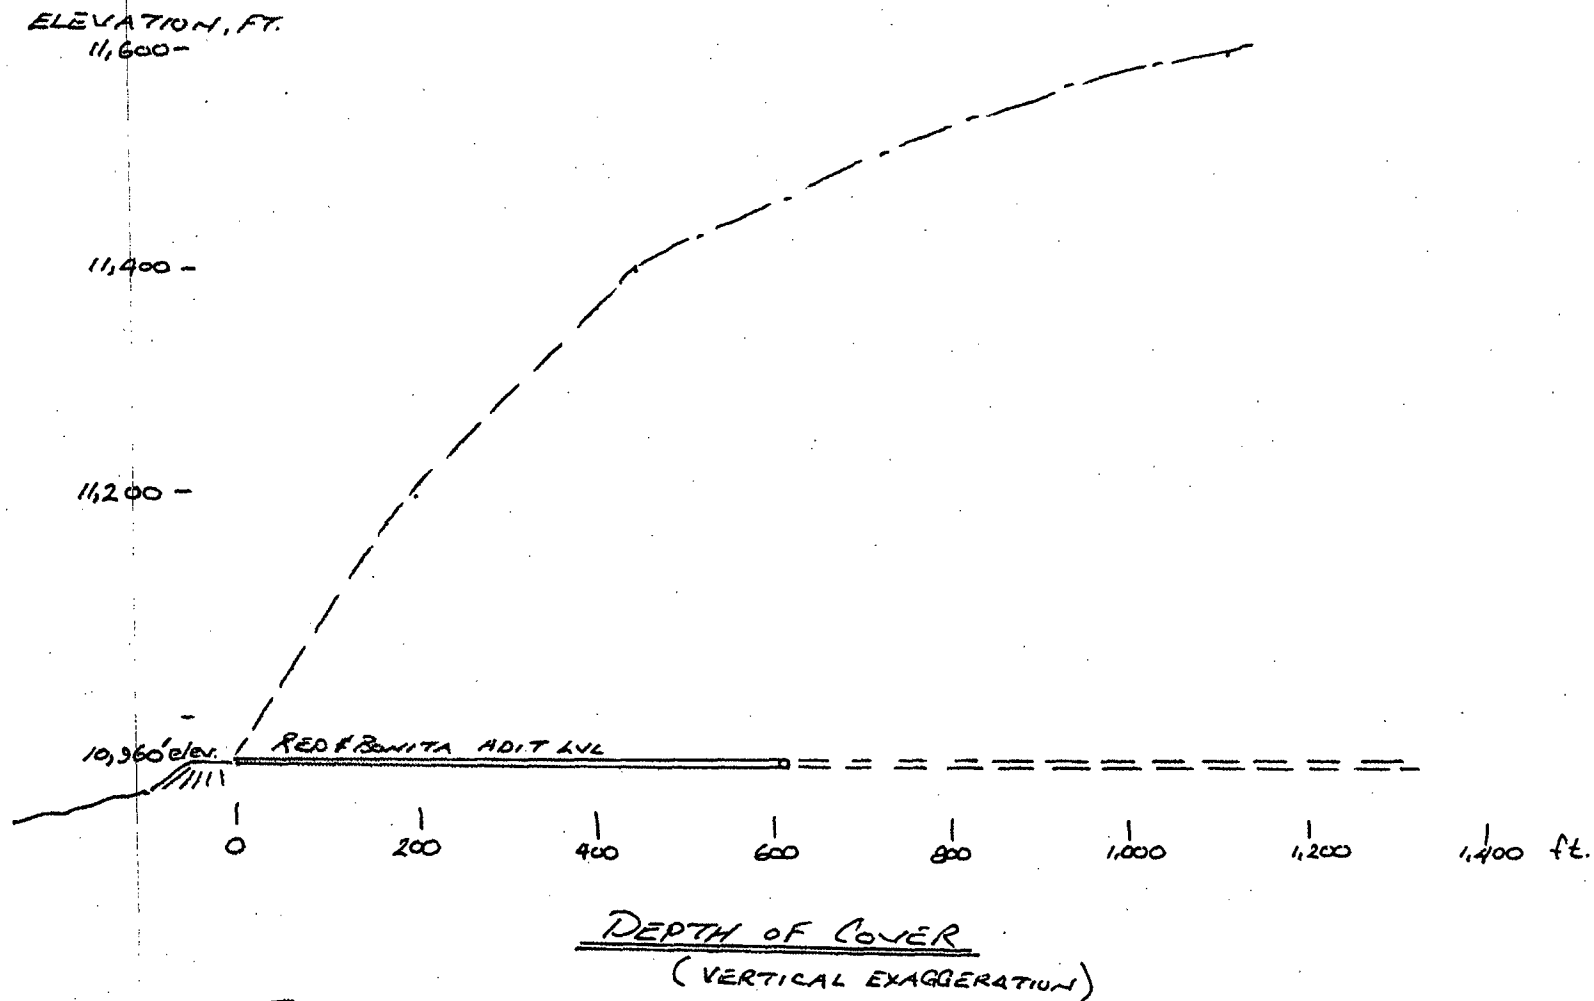
FIGURE 6. DEPTH OF COVER PROFILE ABOVE RED BONITA ADIT

A preliminary cross section along the R&B workings was constructed as part of the bulkhead feasibility consideration (Figure 6). Due to the extremely steep valley walls along Cement Creek there are 400 feet of overburden at 400 feet in from the portal, and 600 feet of depth at 1,000 feet from the portal. A final bulkhead design must take into account the expected pressure head and depth of overburden available to prevent hydro-fracturing of the rock around the bulkhead. In the case of the R&B workings, it appears that sufficient cover exists to continue consideration of a bulkhead if this approach is chosen.
